PIC16C65A

PIC16C65A Rev. A Silicon Errata Sheet

The PIC16C65A (Rev. A) parts you have received conform functionally to the Device Data Sheet (DS30234**D**), except for the anomalies described below.

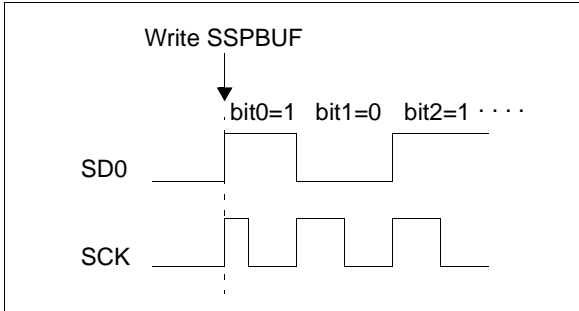
FIGURE 1: SCK PULSE VARIATION USING TIMER2/2

4. Module: SSP (SPI Mode)

When the SPI is using Timer2/2 as the clock source, a shorter than expected SCK pulse may occur on the first bit of the transmitted/received data (Figure 1).

Work around

To avoid producing the short pulse, turn off Timer2 and clear the TMR2 register, load the SSPBUF with the data to transmit, and then turn Timer2 back on. Refer to Example 1 for sample code.

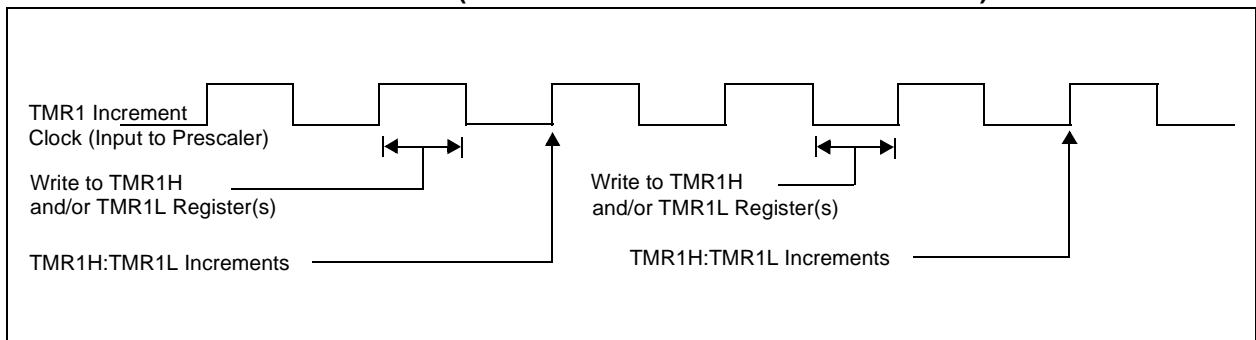
FIGURE 1: WRITES TO TIMER1 (EXTERNAL CLOCK/OSCILLATOR MODE)

3. Module: Timer1

The operation of Timer1 needs some clarification when the timer registers are written and the TMR1ON bit is set.

The internal clock signal, that is the input to the TMR1 prescaler, affects the incrementing of Timer1 (TMR1H:TMR1L registers and the Timer1 prescaler). When the Timer1 registers are NOT written, the Timer1 will increment on the rising edge of the TMR1 increment clock.

When the TMR1H and/or TMR1L registers are written while this clock is high, TMR1 will increment on the next rising edge of this clock.

When the TMR1H and/or TMR1L registers are written while this clock is low, TMR1 will not increment on the next rising edge of this clock, but must first have a falling clock and the rising clock for TMR1 to increment.

Figure 1 shows the two cases of writes to the TMR1H and/or TMR1L registers. Due to the V_{IH} and V_{IL} thresholds on the oscillator/clock pins, external Timer1 oscillator components, and external clock frequency, the Timer1 increment clock may not be of a 50% duty cycle.

The TMR1 increment clock is out of phase of the T1OSO/T1CKI pin by a small propagation delay.
